5.4 Ontario Street, west side

10 Ontario Street

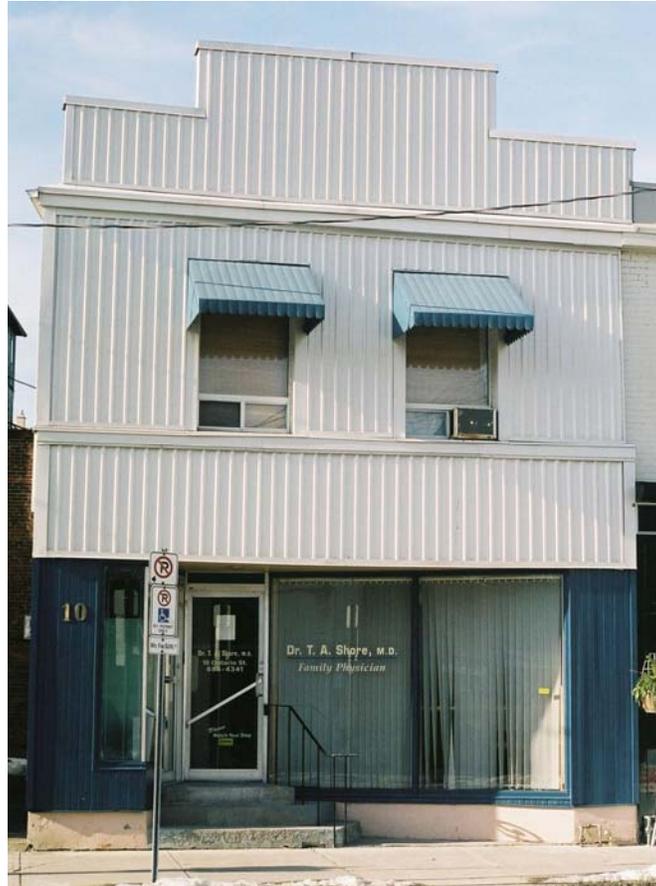
- Two-storey, commercial building with metal-clad top floor and boomtown parapet (c.1890).
- Front Elevation – Traditional building with ground-floor commercial is compromised by later alterations and cladding. Entry, at LH side, is reached by cast-in-situ concrete steps and small landing leading to fully glazed, aluminum-framed door with small transom-window. Wall below windows has concrete render on unknown substrate, while modest stall risers on either side are clad in narrow, vertical v-jointed boards. Similar boards clad piers at either side of façade, and older material (i.e. brick) is assumed to exist behind. Shopfront itself is angled relative to street, having window frames in profiled (painted) aluminum with attached corner pieces, typical of 1950s. Ground floor ends with very deep band of ribbed metal cladding which projects beyond lateral piers and presumably hides other finishes below, including perhaps older shopfront glazing and fascia. At second floor, horizontal band of profiled metal flashing spans full-width at window-sill height. Replacement windows are metal-framed units, with large top-sash over small bottom-sliders. Window-heads are concealed in boxy metal canopies and entire wall surface is, again, clad in vertical ribbed metal, presumably over brick. Band of profiled metal at wall-head probably conceals older cornice within. Stepped parapet is also metal-clad and rises some two feet at either side and a further two feet at centre, presumably to hide pitched roof. Parapet is capped with pre-painted metal flashing.

- Comments – Building appears to be the Sleeping Beauty of Ontario Street. Although shopfront may retain little heritage fabric aside from, perhaps, high-level glazing, there seems a strong possibility that original fabric remains behind extensive metal-cladding above. Selective removal of finishes is encouraged to see what exists behind, and in what condition this may be. Historic photos may also exist. Upper floor window canopies should be removed and windows should be replaced with period facsimiles. If sufficient 1950s material remains at shopfront level a composite approach to this restoration might be considered. *(NAH much of this restoration work has been completed since the photograph was taken)*
