5.6 John Street, west side

16 - 18 John Street

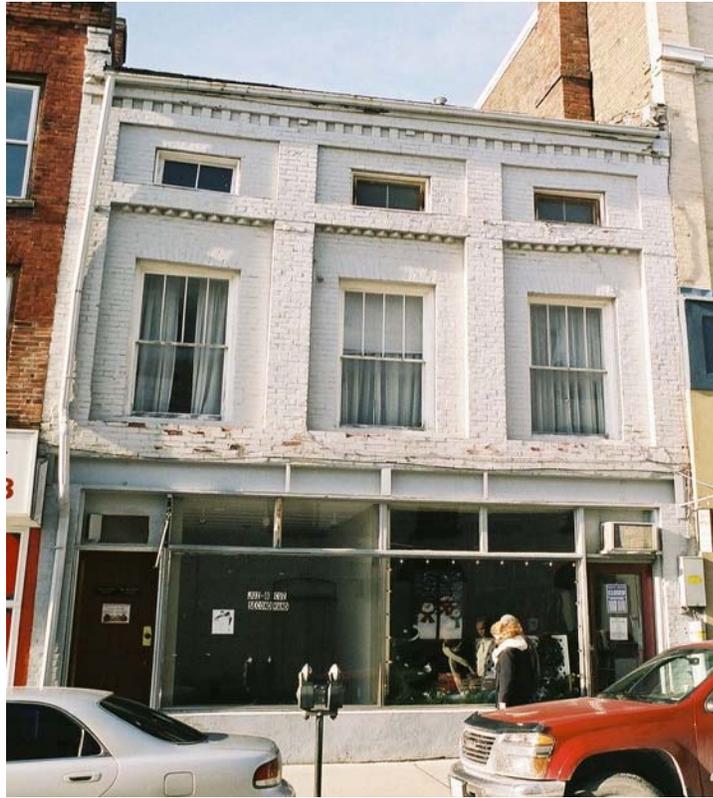
- Three-storey, three-bay (painted) brick building with small windows at top floor (c.1860).
- Ground Floor – At street level, shopfronts at both units have recent doors (under transom panels for AC units) adjacent to large central windows with aluminum-framed, c. 1950s glazing, each with two recent transom windows above. No. 16 has aluminum-framed door and no. 18 has modern, six-panel wood door. There is no fascia nor cornice and exposed, painted steel beam above rests on plain brick piers at either side and central, round iron post.

- Second Floor – At second floor, building is articulated into three bays by plain brick pilasters, each bay having single dog-toothed band at head providing corbelling for projecting masonry above. Centrally placed apertures contain unusual 4/1 windows (assumed to be replacements) with vertical upper panes. Sills are painted, cast-in-situ concrete, with brick flat-arches above.

- Third Floor/Parapet – Upper floor is again divided by plain pilasters into three bays, and appears to be an attic. Small windows are set in recessed brick panels, each aperture having no lintel. Windows seem to be old, removable, two-pane sashes. At parapet, masonry steps out to plane of pilasters. Dentil-like band above is composed of two stacked headers with small, recessed bricks between. Brickwork corbels out slightly at course above, and wooden fascia has old, ogee-type galvanized gutter draining pitched roof to corrugated downpipe at LH side. Roof is invisible from road, and with small chimney at left, while chimney at right side is most impressively extended to rise above roof of tall building to north.

- Comments – An attractive building in rather neglected condition, and suffering from much settlement (assumed to be inactive). At ground floor, shopfronts are simple and lack of fascia and cornice at exposed beam is inappropriate to the context. Second-floor concrete sills – assumed to replace wood – do not project beyond masonry this may be aggravating peeling paint and spalling brick below. Four-pane top sashes seem in fragile condition and should be maintained. RH chimney head needs re-pointing. Removal of paint from masonry is to be encouraged, assuming brickwork below is neither excessively decayed nor varied in type.
