5.4 Ontario Street, west side

20 Ontario Street

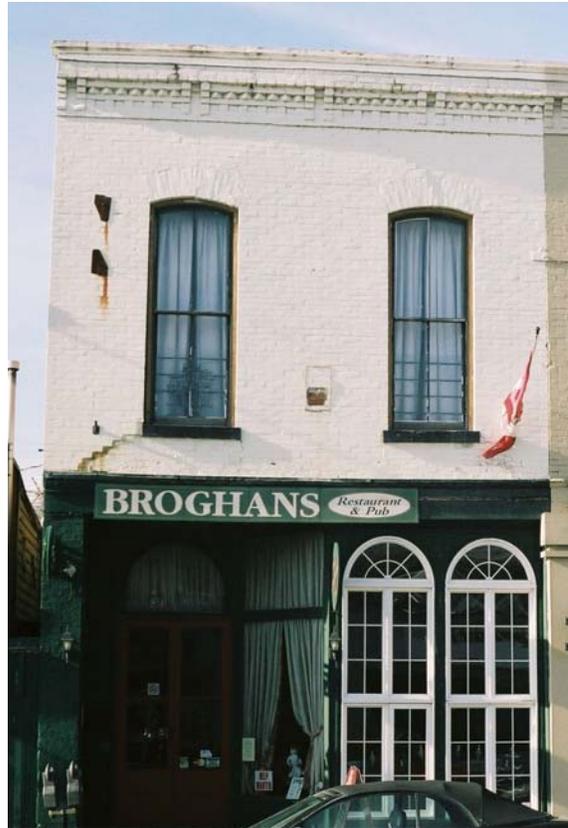
- Two-storey brick building with original upper 2/2 windows and ornate brick cornice (c.1875).
- East Elevation – Imposing, commercial main-street building is similar to no. 24. Ground-floor entry consists of pair of replacement, tall entry doors, each with two upper panes over modest panel, set in recess at LH side. Original arched transom window remains, including capitals below, all apparently in cast-iron, and with unusual, vermiculated fretwork at spandrels above. Ceiling is finished in beaded boards, with crude metal patch at inner corner. Outer wall of recess is also clad in vertical, beaded boards. Shopfront has older portion extending into recess, with vertically boarded stall-riser, and large bottom sash, transom and smaller sash above. Main shopfront is recent, consisting of pair of round-arch French windows, each with stacked pair of vinyl casements having six panes per sash (formed by false internal muntins) with similar-type fanlights above. Low stall-riser, central mullion and spandrels are clad in v-jointed wood. At fascia level, simple wooden beam spans from brick pilasters at either side, with modest cornice at upper edge. Sign is narrow painted board attached near mid-span, and drops slightly below soffit of beam. Second floor is built of (painted) brick masonry laid in common bond, and contains two original, tall 2/2 windows with segmental-headed top sashes. Sills are of painted masonry and segmental-arch voussoirs are 1½ bricks high. Ornate cornice is entirely of brick, divided into four bays, each framed by paired corbels, like wooden brackets, set above stringcourse. Between corbels are band of headers with alternate recessed bricks, dog-toothed band, and corbelled course above. Cornice ends with several courses of projecting brickwork built off continuous course of headers. Wall-head is capped with modest, curved metal elements with deep flashing above.

- Comments – Building is generally in good repair, though vinyl shopfront windows are unsuitable. Transom window over doors and accompanying ironwork are, however, most rare. Masonry cracks at beam ends and upper floor voussoirs result from settlement of main beam, which should be monitored. Brickwork should be cleaned of paint, and old windows require repair at bottom rails, and repainting; but these tall beauties should absolutely be retained.
