5.6 John Street, west side

20, 22, 24 and 26 John Street

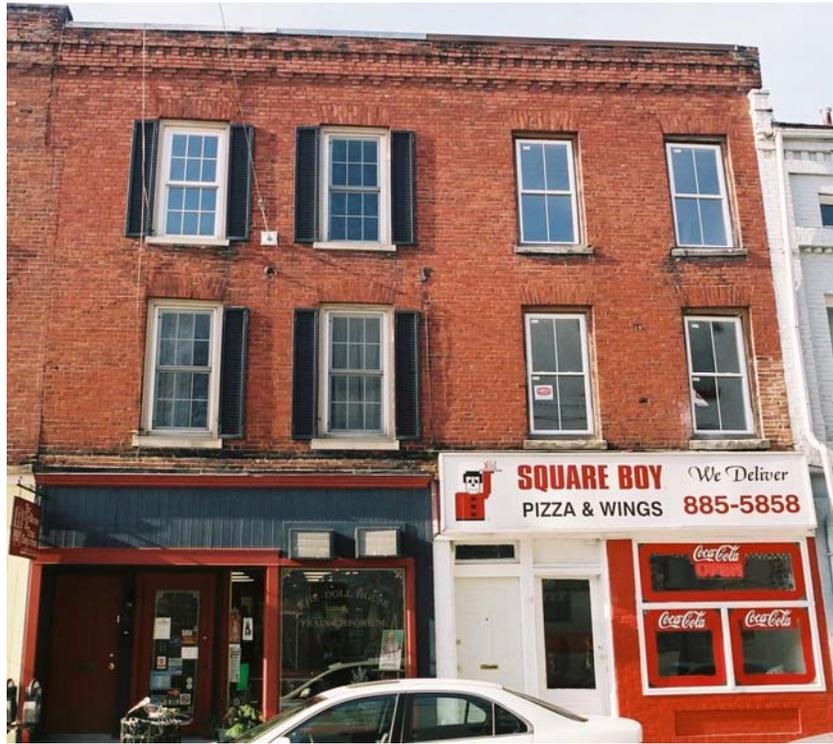
- Three-storey, four-bay, red-brick building with diverse shopfronts and windows (c.1860).
- Ground Floor – At street level, elevation comprises outer shopfronts and near-central door to upper floors. No. 20 has modern, $\frac{3}{4}$ glazed door with plain lower panel, and modern wood-frame shopfront windows over central, recessed brick panel. At no. 22, six-panel wood door is recent, whereas transome window seems old. Entry to nos. 24 and 26 has walls lined with vertical, v-jointed boards throughout, fully-glazed modern door at no. 24 and recent large shopfront windows, and six-panel door at no. 26. Signage is unsuitable, back-lit box sign at right and modest, projecting sign only at left. Fine wooden cornice at left is recent, but elements of old transom windows etc. may exist at upper shopfront level at both properties.

- Upper Floors – At second and third floors, building comprises four plain bays built in attractive, hand-made red bricks laid in Flemish bond. Window apertures have wooden sills (aluminum-flashed at left) and flat-arch voussoirs. Windows are a variety: at right, recent 2/2 units and at left, replacement 6/6 units (with false muntins and full screens). LH windows are smaller, having been inserted into old frames, and have modern shutters screwed to masonry.

- Parapet – Wall-head is crowned by attractive parapet consisting lower machicolations formed of band of corbelled headers with stretchers above, then three courses of plain brick-work, dentil-like band of two stacked headers with small brick between, and at top some four courses of projecting masonry. Parapet is flashed with a variety of metal flashings.

- Comments – This elegant façade is generally in good repair, but suffers from much settlement (assumed to be inactive), especially at RH side. Shopfronts are recent but as mentioned, may conceal older material, given depth of boarded fascia at left (note also flashing witness above). This should be investigated. Shop windows and all doors are unsuitable, and should be one day be replaced in accordance with the Guidelines. At upper level, all windows are new. 2/2 units at right may replicate original windows, though 6/6 seem more probable. 6/6 windows at left, however, too small, and made of an unsuitable material. Old metal flashing at RH parapet needs replacement, and sections to left should be tidied. Re-pointing is needed in various places at failed voussoirs.
