5.1 Queen Street, east side

23 and 25 Queen Street (continued)

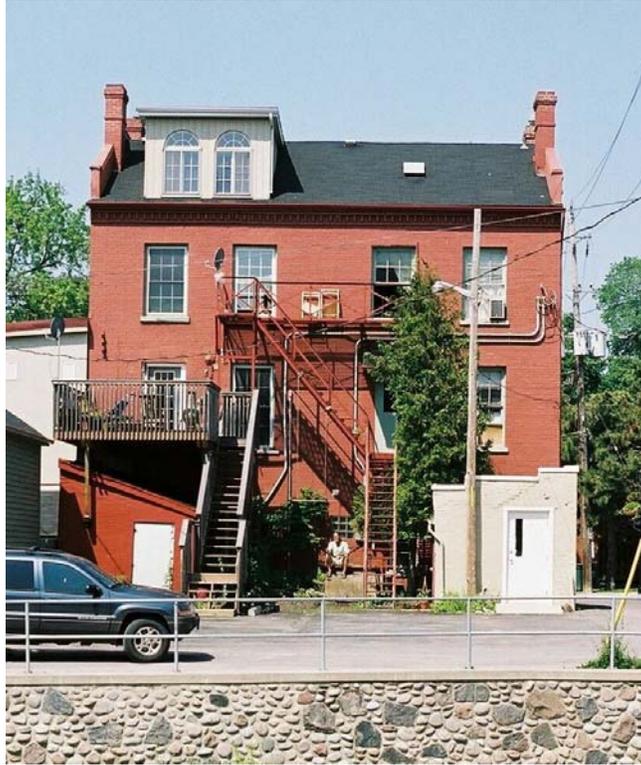
- Side and Rear Elevation – North elevation is of red-painted brick, and contains altered central window at ground floor, original 6/6 window at second floor, and two apparently more recent, smaller 1/1 windows at top floor. Projecting upper and lower bands at pitched and central parapet are attractive feature. Rear elevation resembles front, i.e. three storeys four bays wide, with cornice, roof, parapets and chimneys as described. Apertures have flat-arch lintels with simple, soldier voussoirs. Plastic conduit is something of a feature across this elevation. At ground floor, both addresses have modest, painted-brick, shed-roofed addition (with stepped parapet at no. 23) extending out from side and back walls. Elsewhere, steel, slab-type door at LH side occupies an original opening. Rear is dominated by wooden and metal stairs rising, respectively, to second-floor wooden deck at no. 25 and second- and third-floor metal landings at no. 23. At second floor, two original windows remain, and two have been replaced with modern, partly glazed doors. At third floor, windows at no. 25 are 6/6 replacements (with false muntins), while 6/6 originals remain at no. 23. No. 25 also has large, shed-roofed dormer clad in board-and-batten siding, and containing two, round-headed apertures each with pair of 6-pane, vinyl casements under arched transom windows (all with false muntins). Old wooden hydro pole, with utilitarian fittings, suits back-lane aesthetic.

- Comments – Tall brick building is a unique presence on Queen Street, and more in keeping with Walton, providing an indication of what has been lost along this road. Stucco at ground floor is assumed to hide alterations and possibly variety of brick types, whereas remainder of building is little altered, aside from various replacement windows. Only following careful investigation of the existing fabric, and ideally archival photographs also, might one be able to determine the original configuration here. Steel plates at front, second and third floor levels suggest former problems with front and rear walls spreading, now assumed to be inactive. Cement pointing and render at parapets and chimneys should be carefully removed and masonry repointed. At rear elevation, hodge-podge of old one-storey additions, wood and steel stairs, and even new dormer, give an appealing back-lane presence. Modern doors at second floor, especially “French” door with peripheral white vinyl frame, are out of keeping, as are long PVC electrical conduits.
