5.4 Ontario Street, west side

24 Ontario Street

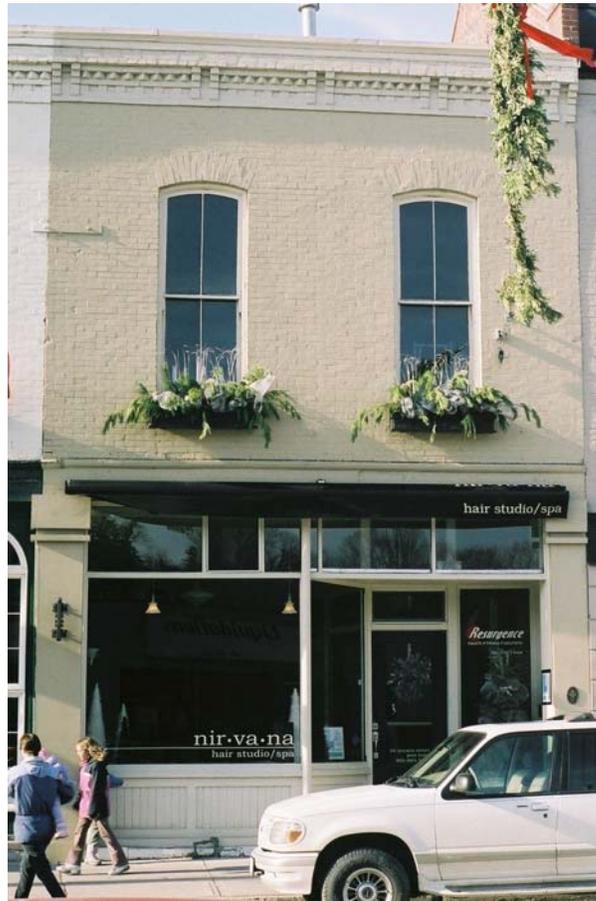
- Two-storey brick building with original, upper 2/2 windows and ornate brick cornice (c.1875). Building is **Designated** under the Ontario Heritage Act, Part IV.

- East Elevation – Imposing, commercial Main Street building is similar to no. 20. to either side, stuccoed brick piers with box-like capitals, frame recent shopfront. Recessed entry at RH side had boarded deck over concrete over limestone blocks, which latter extend across base of building. Door is replacement, ¾ glazed, wooden door with small lower panel. Ceiling above is finished with beaded boards, with two cast-iron vents presumably venting former internal gas lamps. To RH side is large window over vertical, v-jointed boards, in recent frame. Adjacent wall of recess is clad in vertical, v-jointed boards. Transom windows throughout are in same plane as shopfront, and over boarded ceiling. Main shopfront has tall, vertically boarded stall-riser with recent frames, with large pane above and recent, varied fenestration with opening units. Signage is restricted to modern letters in lower shopfront windows, and lettering at RH side of retractable awning. Shallow fascia above has modest upper mouldings only. Second floor is built of (painted) common-bond brick masonry and contains two original, tall 2/2 windows with curved rails at top sashes. Sills are hidden by window-boxes stone, while voussoirs are 1½ bricks high. Cornice is built entirely of brick, divided into four bays by paired corbels similar to wooden brackets, set above stringcourse. Between corbels are band of headers with alternate bricks recessed, dog-toothed band, and additional corbelled course above. Cornice ends with several courses of projecting brickwork built off continuous course of headers. Wall-head is capped with modest, curved metal elements with deep flashing above.

- Comments – Building is generally in good repair, with recent shopfront having older, altered elements at stall-risers, and old cast iron vents at ceiling above. Settlement in masonry at upper floor voussoirs probably results from sagging of main beam, which should be monitored. Paint in this instance is not spalling, but should be carefully removed from old brickwork. Old, sash and case windows seem in good repair, and benefit from recent paint.
