5.5 John Street, east side

25 John Street

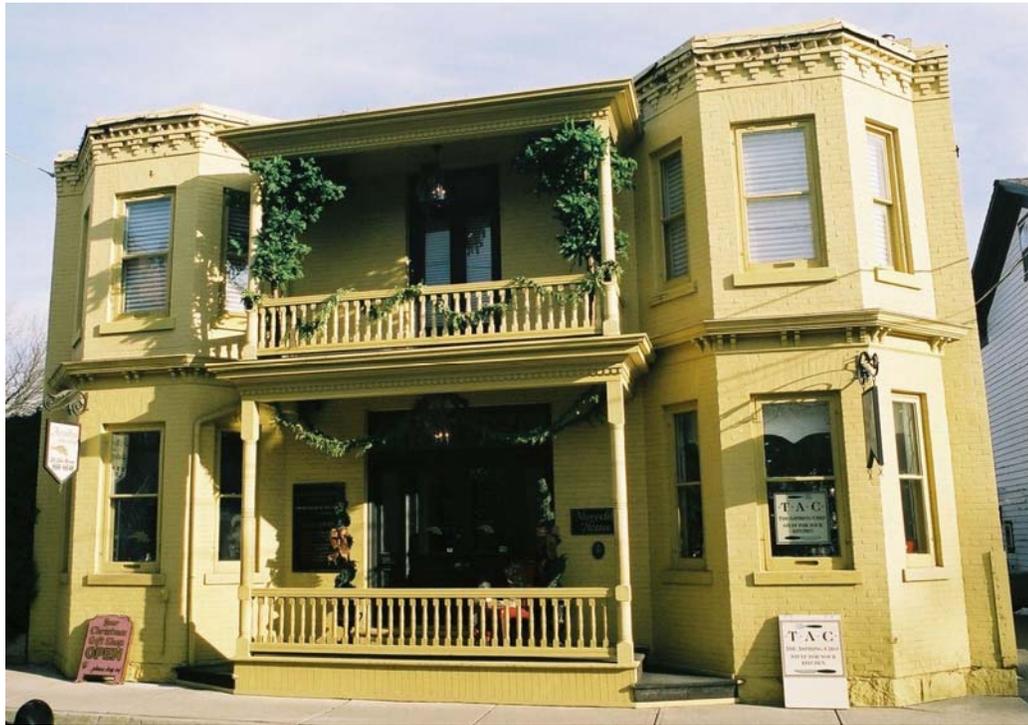
- Symmetrical, two-storey, flat-roof brick building with two-storey bay windows, **Designated** under Ontario Heritage Act Part IV: “good example of late Victorian Brick building.”(c.1880)

- Comments – Dignified building is assumed to been restored. Brick colour gives rather lively presence on John Street. Current situation at parapet compromises appearance, and this aspect should be remedied, replicating period details as closely as possible. At rear, one-storey, painted brick structure adjacent to Lent Lane has various settlement cracks and needs attention. For possible development of parking lot to north, see the Guidelines.
