5.4 Ontario Street, west side

26 Ontario Street

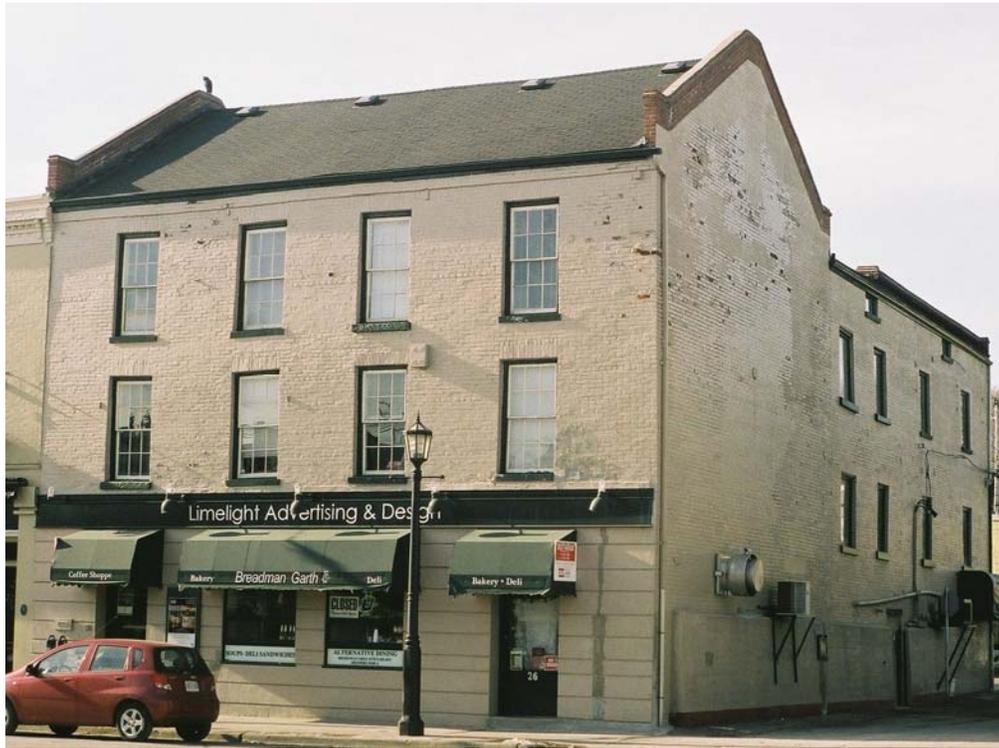
- Georgian, three-storey, pitched-roof, painted-brick building (c. 1855) with large rear addition having lower floor levels. Building is **Designated** under the Ontario Heritage Act, Part IV.

- East Elevation – Tall, symmetrical building is a dignified presence towards the end of Ontario Street. Ground floor appears extensively reworked, having been re-clad in stucco, with bands of rustication in varying widths. Doors at right- and left-hand ends are recent, half-glazed doors with single, horizontal lower panels. Shopfront windows are two large, single-pane, fixed sashes without intrinsic merit. Apertures have half-gambrel-shaped, plastic-clad canopies, and fascia above, with simple signage, consists of strip of painted sheet-metal top-lit by 5 spun-metal light-fixtures. Second and third floors are of painted brickwork (assumed to be monochromatic red) with header courses typically every sixth course. Windows at both levels are four, uniformly spaced, old 6/6 units, some with stone sills but most with later concrete sills, and with flat-arches formed by single course of brick soldiers (rebuilt with steel angles at second floor, nos. 1, 2 and 4). There is evidence of settlement throughout façade. At wall-head, masonry corbels out slightly below top three courses, and modest wooden fascia is hidden by K-type aluminum gutter with modern downpipe to north. Roof is framed by parapet walls built of sloping-course masonry which rises well above roof-line and has flattened portion adjacent ridge. Masonry stumps visible within parapets indicate location of former chimneys at front and rear pitches. Roof is clad in black asphalt shingles.

- Maitland Street Elevation – Ground-floor sills at front block indicate former windows. Lower, 3½ storey addition, also of painted brick, extends along side street and has single-pane windows with wood, concrete or stone sills, and brick voussoirs often with metal angles.

- Comments – Building is in fair repair, with recent ground-floor stucco and shopfronts being foreign to original. Recent interventions should be reconsidered, and restoration might be suitable both to commercial needs and to character of original building. Paint should be carefully removed from brickwork. Four chimneys, once major and significant features, should be rebuilt to period details; and ideally a cedar-shingle roof should be installed, at least at front pitch. At Maitland Street, paint should be removed, vents and AC relocated, and a 3rd floor wood lintel seems to be failing. An open, commercial presence here would enliven lane.
