5.5 John Street, east side

27 John Street

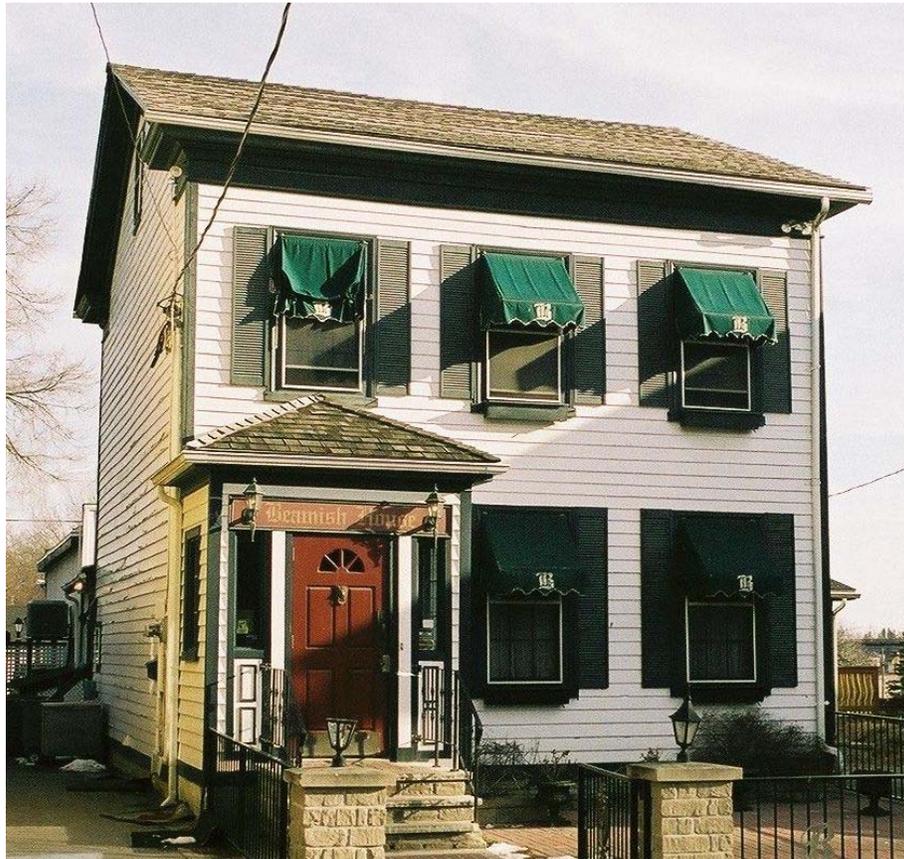
- Two-storey, pitched-roof, clapboard building with later porch and large rear addition (c.1848). Twice-relocated building is **Designated** under the Ontario Heritage Act, Part IV.

- Front and Side Elevations – Tall, narrow building (former home) now has commercial occupancy. Porch is modest, cedar-shingled, hipped-roof structure at LH side, reached by small flight of recent, stone-clad steps. Entry has modern wood door with four under integral “fanlight,” framed by tall, one-pane sidelights with planted mouldings at lower panels. Building is clad in closely spaced clapboard framed by plain corner-boards. Windows are old, 6/6 units throughout (behind metal storms) within period moulded casings. Thick sills are hidden by metal window boxes, and shutters (without central rails) and canvas canopies are recent. At wall-head, deep fascia with lower bullnose and robust cornice, has full returns at side walls. Similar profiles at gables extend parallel to roof pitch. Soffits are finished in plain boards and gable fascias have robust shingle mouldings. Roof is clad in textured, grey asphalt shingles with conventional aluminum rainwater goods and there are no chimneys.

- Rear Addition – An extensive flat-roofed addition exists to rear and south of building, latter portion having also false, mini-mansard roof. Addition walls are stuccoed and windows are essentially invisible from Lent Lane. Large rear terraces have pickets derived from traditional type, being straight in elevation and profiled in section. These combine with upper and lower rails to meet code requirements in a sympathetic way. Several old-style lanterns decorate north terrace in a somewhat oddly, given contemporary aspect of railing.

- Comments – An attractive house successfully adapted to use as pub restaurant. Front door is modern and suburban and should be replaced with suitable, panelled or half-glazed and panelled door; and shutters and canopies are out of keeping with original building. Lanterns at north rear terrace might be replaced with discreetly modern units, and railing at south terrace should be painted as at north terrace. Clapboard at north elevation needs repair and painting, and a suitable brick would enhance period aspect of building.
