5.6 John Street, west side

**28, 30 & 32 John Street**

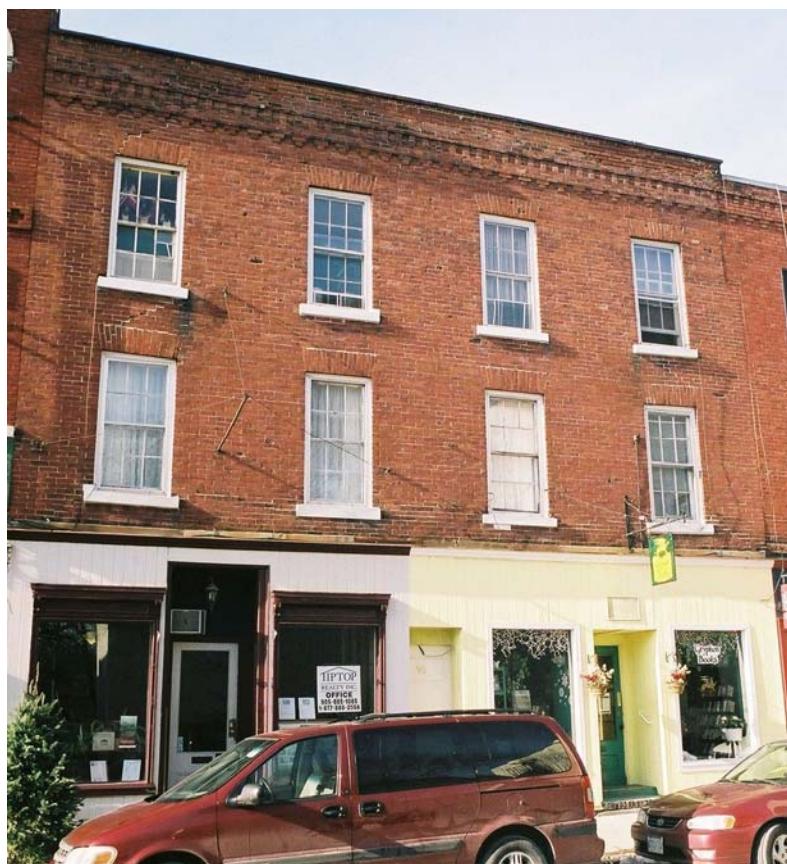
- Three-storey, four-bay red-brick building with recent shopfronts, original windows (c.1860).
- Ground Floor – At street level, elevation comprises outer shopfronts and central door to upper floors. No. 28 has recent $\frac{3}{4}$ -glazed door with single lower panel, and modern wood-frame windows, all within large expanse of vertical v-jointed boards. No. 32 is lined with similar boards, and has older, $\frac{3}{4}$ -glazed door with single lower panel. Front windows here, including ornate wooden frames, are recent, though tall, 2-pane windows within recess to door are old. Old posts adjacent entry have repair at bases, bevelled edges above, and upper stop chamfer. Door to upper floors (no. 30) is flush-ply door, noticeably lacking transom window. There is no actual fascia nor signage throughout, and small cornice over vertical boards seems recent.

- Upper Floors – At second and third floors, building comprises four plain bays built of hand-made red bricks laid in common bond. Window apertures have metal-flashed wood sills and flat-arch voussoirs, and there is much settlement in bays one and four. All windows are original 6/6 units (all with frames for metal storms) and seem in reasonable condition.

- Parapet – Wall-head is crowned by handsome parapet similar to adjacent building to north, and consisting lower machicolations formed of band of corbelled headers with stretchers above, then three courses of plain brick-work, then dentil-like band of two stacked headers with small brick between, and at top several courses of projecting masonry. Parapet is capped with rusted sheet-metal flashing which seems to be sound.

- Rear Elevation – Lane elevation has numerous old 6/6 windows in rather patchy brickwork
- Comments – Elegant façade is generally in good repair, though suffering from settlement (assumed inactive) at outer bays. Ground-floor shopfronts may hide older material, given depth of boarded fascias and remaining old posts and glazing at no. 32. Here, windows are somewhat unsuitable, doors less so; and old windows at entry to no. 30 should remain and cornices etc. over adjacent windows are unusual and worth retaining. At upper levels, 6/6 windows should be retained and repaired. Severe cracks at areas of settlement should be repaired and repointed, and upper parapet requires much repointing.
