5.6 John Street, west side

34, 36, 38 & 40 John St.

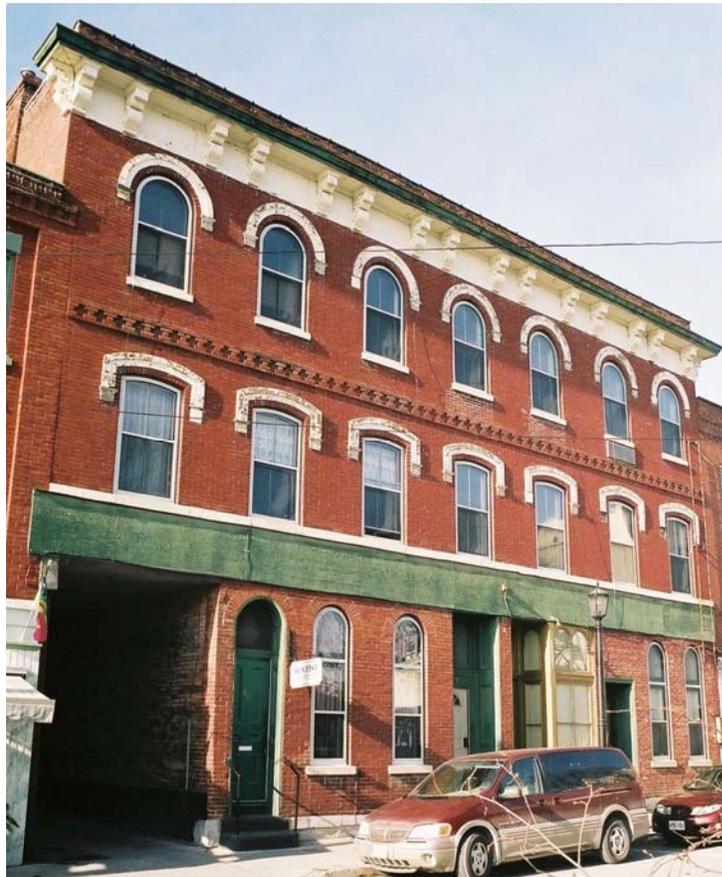
- Tall, three-storey, seven-bay red-brick building with robust consoles at top cornice (c.1865).
- Ground Floor – Rhythm at street level differs from that of upper stories, and comprises both residential units and commercial units, and large coach passage at LH side. Masonry throughout is of hand-made red bricks in common bond, with rubbed brick soldiers at voussoirs. Unites are reached by modest flights of steps set mostly within recesses having panelled sides and soffits, all with bolection mouldings. Nos. 34 and 38 have recent, panelled metal door with integral “fan-light.” Masonry at no. 34 is rebuilt without transom window, while 38 has original pair of arched transom windows. Door to no. 36 is recent, and has pair of round-headed lights over two plain panels and two-pane transom window. Shopfront (to right) has 4-pane sash under two round-headed windows, and similar, half-width treatment at recess; all elements being recent. No. 40 has unusual (new) six-panel door with small central panels as panels of recess, under old round-headed transom windows. At no. 34 and 40, thick wooden sills and tall, narrow windows remain, with 1/1 units under round-headed top windows (all with metal storms). Fascia is only plain plywood and this runs full length of building. At second floor, elevation has seven, 2/2 windows (with metal storms) in segmental-arch apertures, each with rendered brick hood-mouldings dropping at jambs to wooden corbels. Sills are hidden by deep, white metal flashing. Top of second storey has band-course with recessed bricks forming crosses throughout. At third floor, building has seven, round-headed 2/2 windows (with metal storms) in round-headed arches. Narrow brick voussoirs are framed by profiled wooden hood-mouldings, again built off modest corbels. Wall-head has deep cornice with robust wooden consoles in pairs either side of windows. Consoles seem formed of upper and lower sections, with incised ornament at sides. Wall between is rendered and painted, and soffits above have v-jointed boards. Wooden, ogee-shaped moulding finishes fascia of cornice. Parapet is built of plain masonry with glazed, interlocking tiles forming protective coping. Rear elevation retains many old 6/6 windows.

- Comments – Façade is in good repair, though hood-mouldings and wooden corbels need some repair and painting, and some have fallen off. At ground floor, old panelled recesses and soffits, and old transom windows are rare and in good repair. Metal storm-windows, though not beautiful, protect old windows and should remain until a sensitive interior double-glazing system is installed. Parapet needs repointing, and a suitable lower cornice should be reinstated. Rear windows are wonderful.
