5.5 John Street, east side

35 John Street

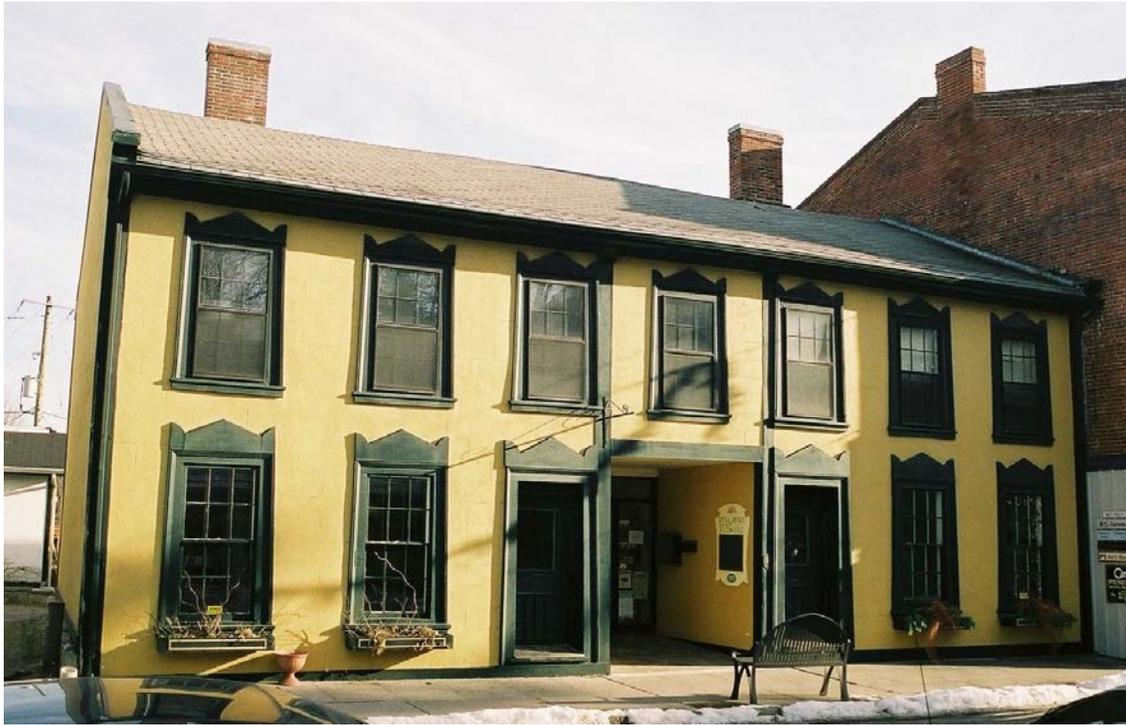
- Two-storey, pitched-roof, rendered frame building with central recess and rare tapered casings (c. 1850). Former Midland Hotel is **Designated** under the Ontario Heritage Act, Part IV.

- Front Elevation – Symmetrical, timber-frame building, with three bays either side of large central aperture, is unusual in many ways. Walls are finished in textured, incised render imitating ashlar masonry, which is assumed to be (or replicate) original finish. Walls are trimmed with continuous wooden baseboard, plain corner-boards, and two similar boards either side of central recess, the latter being cut to accommodate tapered window casings. Incised render extends into central recess, which houses modern glass screen and door giving view through to terrace behind. Doors either side of recess are half-glazed with four narrow, vertical panels below. Shallow door recesses are trimmed at jambs and head with panels having bolection mouldings. Adjacent windows are old 6/6 units with narrow sills and plain trim below (and flower boxes at ground floor), framed by tapered architraves (in Greek Revival style). Window-heads have unusual, wooden, crown-like trim over top architraves. At second floor, similar windows (behind metal storms) and architraves exist at all bays, with window-head trim being slightly smaller. Wall is rendered up to deep, cove-type cornice, which is broken by four simple, concave wooden brackets crowning vertical boards. Soffits have plain wide boards. Pitched roof is framed by modest brick parapet at north side and abuts building-wall to south. Parapets is flashed in pre-painted aluminum, roof has light-grey asphalt shingles and rainwater goods are modern aluminum profiles. Two wide, plain brick chimneys rise from just beyond roof ridge, and are oriented parallel to length of building.

- Rear Elevation – East side of building is also rendered, but without incisions simulating ashlar masonry. Fenestration is much altered except at ground-floor outer bays. At second floor, outer windows have been replaced with sliding doors leading to recent wooden balconies. Three original, top-floor 6/6 windows with plain casings remain (behind metal storms), the most southerly being set lower, suggesting a staircase within.

- Comments – This is a rare building with many original elements intact. Most significant are the incised render, the front windows and their tapered-and-crowned trim, the panelled doors and door recesses, the longitudinal chimneys and the five extant 6/6 rear windows.
