5.2 Queen Street, west side

6 and 8 Queen Street (see also description in Stokes Walton Street District Plan)

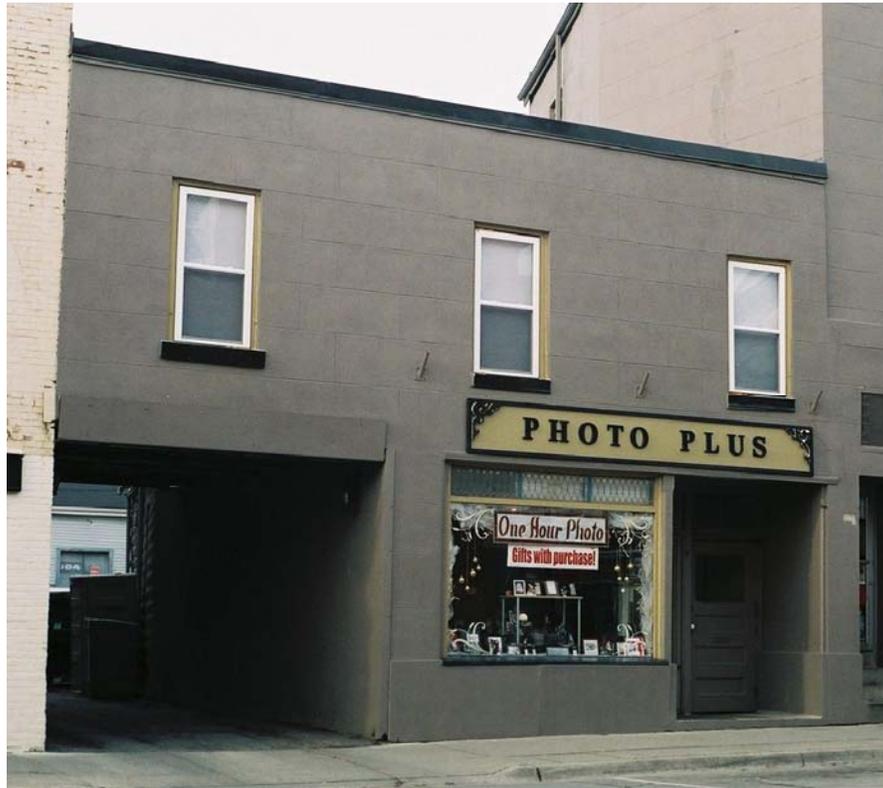
- Two-storey, rendered-brick, commercial building with coach passage at south side (c. 1890). Building is contiguous with Horner Building to north, and so **Designated** under OHA Part IV.

- Front Elevation – Traditional, main-street brick building, now covered with painted, incised render, has ground-floor commercial at north side, with recessed entry to shop and second-floor apartments at far RH side. Coach passage, at south side, is framed with narrow angle-iron at RH side and deep steel plate above. Walls within passage have painted brick at left and plaster-on-lath at right. Shopfront has aluminum-clad sill over boarded-up stall-riser, with cladding perhaps hiding older materials. Above large picture window, in wooden frame, are old transom windows with interwoven, segmental kames with various types of glass within three separate sashes, and additional unit at recess to entry. Shopfront corner-post, has bevelled edges and elegant lamb's tongue stop-chamfer. Floor are recess to entry is terrazzo, with central yellow area. Door to shop (no. 8) is $\frac{3}{4}$ glazed, period-type door with bevelled-edge window, while adjacent door (no. 6) is old, wide $\frac{1}{3}$ glazed door with three horizontal panels, and with two-pane transom window above. Post between doors is as corner post. Shopfront has no fascia and instead has unusual large wooden sign with simple letters and fretwork at upper corners. Second floor is rendered as ground floor, and contains three new $\frac{1}{1}$ windows (replacing $\frac{2}{2}$ originals). Sills are flashed in aluminum, and render incisions above are haphazard relative to potential lintel locations. Wall-head has single, projecting element with deep metal flashing above.

- Lane Elevation – Side wall beyond passage is early pre-cast concrete blocks, imitating stone.
- Comments – Small building has a various interesting elements, especially at shopfront level. Rendered wall surface is out of place and though similar to building to north, removal is encouraged. Absence of beam or fascia over shop window is odd and there may be old materials hidden here, as also at stall-riser. Recent loss of original $\frac{2}{2}$ windows is unfortunate and $\frac{2}{2}$ form should be replicated, in wooden units.
