**5.6 John Street, west side**

**64 John Street** (south)

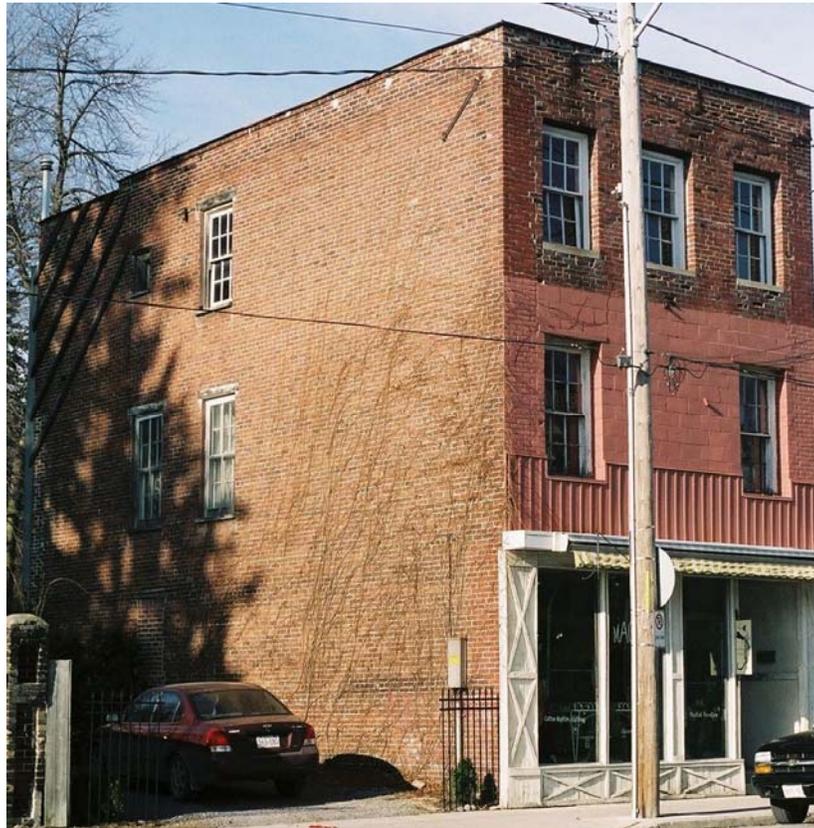
- Three-storey commercial building with extensive rebuilt masonry at upper levels (c. 1870 and later).
- Ground Floor – At shopfront level, wooden materials are recent, used in a rustic contemporary manner. Stall-risers are finished with rough vertical boards having modern-section, face-applied frames and central cross-bracing. Large piers at either side are finished similarly, while narrow intermediate supports have simpler wooden cladding. Actual glazing framing is aluminum, and front door (to RH side) is similar. As at buildings to right, area of traditional fascia and cornice is finished with painted, ribbed sheet-metal and, again, striped yellow awning contributes to heritage streetscape. At second floor, pair of old, 6/6 wooden windows have concealed sills and exposed, metal-angle lintels. Masonry to either side of windows is painted red-brick laid in common bond, with outer window-jamb apparently rebuilt. Masonry between and above windows is painted concrete-block, as at building to right. At third floor, masonry is somewhat as described but in unpainted brick, with small adjacent areas rebuilt using reclaimed brick starting inwards of line 4” beyond outer jambs. Lintels are concealed angle-iron without voussoirs or headers, and plain parapet is obviously recent. Fragments of original decorative parapet elements remain at both upper corners, particularly at RH side. Wall-head is capped with rowlock headers immediately below projecting thin metal flashing.

- South Elevation – South elevation is plainly visible on account of adjacent open area and garden, and is built of hand-made red brick in common bond, with headers every sixth course. Wall contains two, bricked up apertures (one with voussoirs) at ground floor, two 6/6 windows at second floor, and one 6/6 window at third floor, all with modest, unpainted wooden sills and lintels. Small, single-pane casement exists towards rear of third floor, and top rear corner has five diagonal wooden braces.

- Comments – This is an anomalous building. Much of upper two floors has rebuilt masonry, and original form is not easily determined. It appears that old brick was for some reason replaced in central and upper areas of façade. Rebuilt sections, and concrete block, are not so intrusive and might remain, since there may be an associated narrative. This aspect should be investigated. Reinstatement of decorated brick parapet is encouraged, and introduction of suitable signage fascia, in place of vertical metal cladding, would be welcome. Shopfront is expendable whereas south wall and all old elements which it contains, should be maintained. Braces may require maintenance too, in due course.
