5.4 Ontario Street, west side

30 Ontario Street

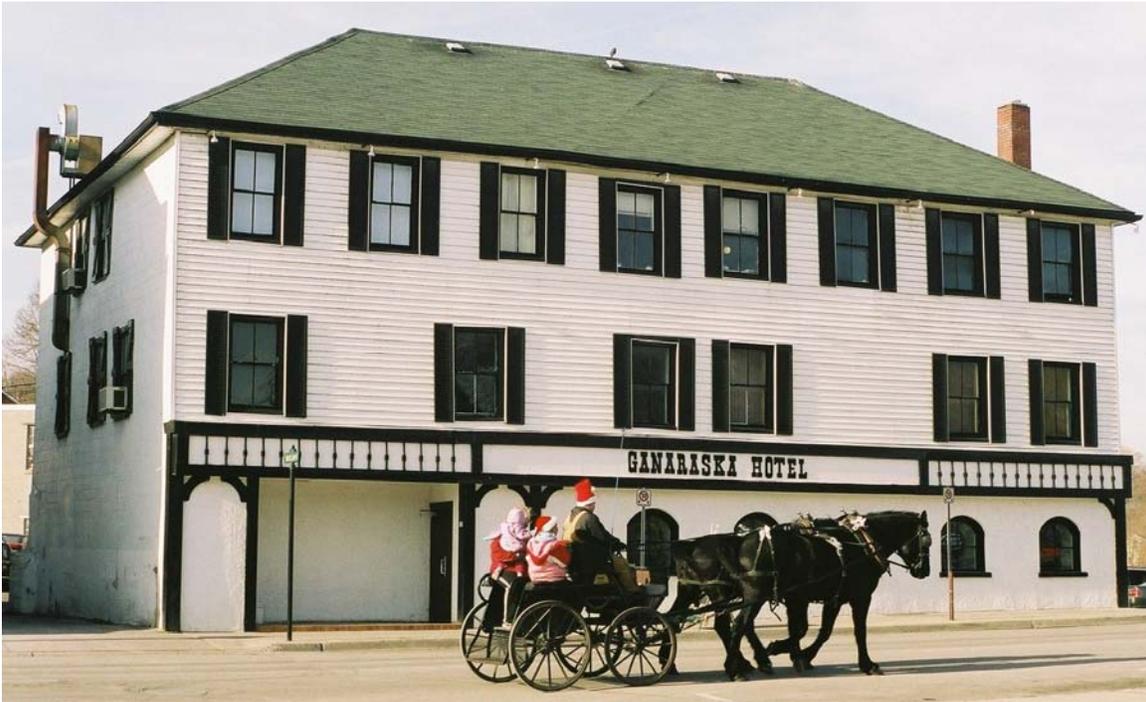
- Traditional, three-storey, hipped-roof clapboard hotel with altered ground floor (c.1870).
- East Elevation – Large, asymmetrical building is a significant presence adjacent Ganaraska River. Ground floor is much reworked, with elements of pseudo-Tudor framing, particularly at two round-headed, blind arches towards LH side. Wall between arches is recessed and contains slab-type doors in return walls at either side, with blank stuccoed wall between. Remainder of ground floor to right contains five, small, four-pane, single-sash, recent thermopane windows framed in rough-sawn wood and with segmental-arch heads. A Tudor-inspired, stucco frieze with band of spindles at either side, spans full width of building, with words “Ganaraska Hotel” centrally placed. At upper levels, wall is clad entirely in closely spaced, grained vinyl siding (assumed to cover old render) with 6 unevenly spaced windows at second floor and eight, more-regularly-spaced windows at top floor. Windows are old, 2/2 units, all with cases flashed in aluminum. All windows now have louvred aluminum shutters. Soffits are aluminum-clad, plain fascia has aluminum gutter, roof has black asphalt shingles. South wall retains original wall surface of plaster-on-lath, with plaster incised to simulate ashlar masonry. 5 randomly placed windows at upper floors are 2/2 units as at front, but have unusual, older wooden shutters formed of vertical boards with upper and lower diagonal bracing spanning to central rail. Rear elevation shows L-shaped plan of building, and bulk of plastered wall has similar 2/2 windows without shutters. North wall is half rendered, with vinyl siding towards front. Prominent metal fire-stairs exist at north and west elevations, and unobtrusive, one-storey addition spans length of west wall, extending from south wing.

- Comments – Old building combines interesting old features and less suitable recent elements. Although current aspect is one of an “olde” hotel, south elevation shows nature of original wall materials and these should be revealed, repaired and reinstated/replicated as appropriate. Thus aluminum and vinyl elements should be removed, render repaired, and ground floor altered to reflect either original configuration, or to a type more suitable to age and character of hotel. Diagonal line in front roof suggests presence of former hip, which is interesting, if only to the observant and curious historian. Hotel is well-placed next to Ganaraska River and holds various opportunities for outdoor terraces to north, to west and on Maitland Street to south. For possible future buildings on lots to west and north, see the Guidelines.
