5.5 John Street, east side

**57 John Street**

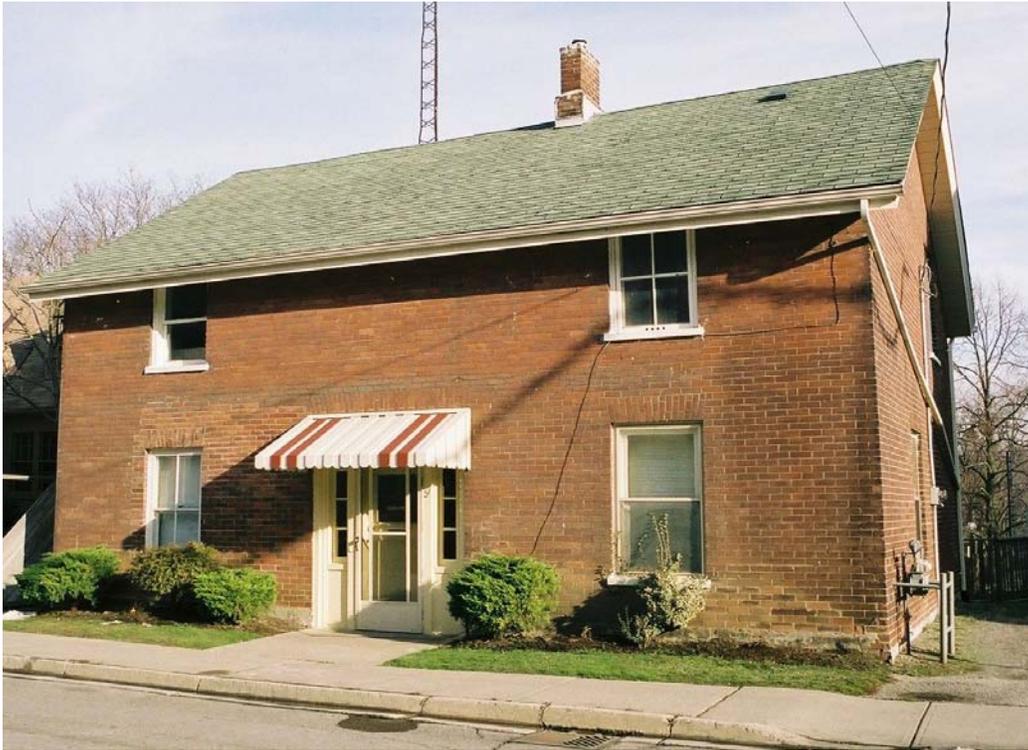
- Georgian, pitched-roof, two-storey red-brick house with period front doorway (c.1865).
- **Description** – Long, gabled house has unusual aspect, with widely spaced windows, particularly at upper floor. Masonry is unornamented, common-bond red brick throughout, built off typical, rubble limestone foundation. Rebuilt brickwork at LH side suggests alterations in this area, although not readily comprehensible from exterior. Central **front doorway** comprises old, half-glazed door with single lower panel (behind metal storm door), set between four-pane sidelights with plain boards in lower regions, now partly hidden in concrete slab. Transom window is small, three-pane unit with broad mullions at either side, with very wide, flat-arch above. Modern, two-tone metal canopy over doorway obscures both arch and transom, and is an unsuitable later addition. **Windows** to either side are later, 1/1 units with original, narrow wooden sills (with period 4-pane storm at left and metal storm at right). Flat arches above contain stretcher and header voussoirs, and rise uniformly to joint-line four bricks above. At **upper floor**, low 1/1 windows (with 4-pane storm at RH unit) are set tight against eaves, with narrow wooden sills as at ground floor. **South elevation** is brick, with two 6/6 windows (with metal storms at ground floor), while north elevation is clad in textured vinyl siding, also with 6/6 windows. Soffits and fascias are aluminum-clad and rainwater goods are conventional aluminum profiles. **Pitched roof** has green asphalt shingles, and a single chimney, on older base, exists at unusual location near center of ridge.

- **Comments** – Parsonage is apparently Georgian but with unusual features, such as 1/1 ground floor and small, upper-level windows; unlike 6/6 windows at end walls. These presumably indicate changes over the years and should be retained. Building is in good repair, though metal canopy over front door and aluminum cladding at soffits and eaves should be removed. Metal storm door is also unsuitable and removal would improve appearance. Chimney requires repointing, and should be rebuilt in upper portions to suitable period details; though older chimneys may have existed elsewhere, as should be apparent from internal roof structure or sheathing. Restoration of such aspects, and installation of a period roofing material (i.e. wood shingles) would enhance appearance of interesting and attractive house.
