### 5.6 John Street, west side

#### 68 John Street/47 Pine Street South

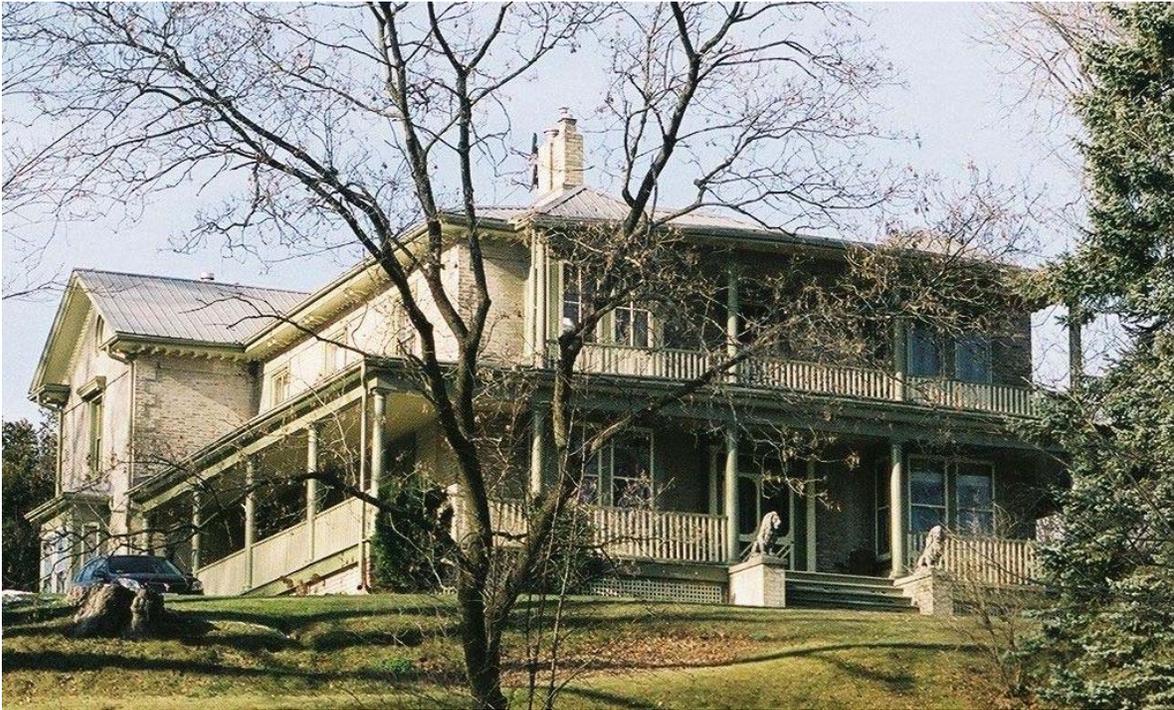
- Italianate, buff-brick house (c. 1860) with large verandah, altered entrances, and addition at east side, 2<sup>nd</sup> floor. The house is **Designated** under the Ontario Heritage Act, Part IV. This large house, set high on a hill, has access via brick gates on John Street and winding drive, and also via more recent, cast concrete gates and drive off Pine Street South.

- East Elevation, Ground Floor - L-shaped house has symmetrical façade facing east, at top of old drive from John Street. Hipped-roof verandah at north, east and south sides has traditional, full-height columns, with turned bases and capitals and square pads at top and bottom. High wooden railing between columns has plain top and bottom rails and simple square-section pickets, suggesting that all elements are recent replacements. Verandah ceiling is finished with narrow, v-jointed boards. East entry, assumed to have been original principal entrance, is reached by broad, central flight of wooden stairs flanked by lions on plinths at either side. Inner doors are behind traditional wooden screen doors, and are set within projecting, rectangular vestibule with traditional, full-height columns at corners. Ground floor windows at either side are within similar square bays (which appear to be recent) and consist of paired 1/1 units at face and smaller, single 1/1 units at sides (all with 1/1 storms). Bays are trimmed with plain corner pilasters and wooden panels below windows. Masonry is buff brick throughout, with projecting quoins extending full-height at corners.

- East Elevation, Second Floor – At upper floor, recent bay windows are as described (with four-pane storms at central units), and flank single door (assumed to have been once a window) to recent, upper verandah having projecting roof curved in plan, supported by four slender columns. Joist framing of roof is plainly visible from below, unlike ceiling at level below. Buff-brick masonry is as at ground floor, with slightly corbelled course near wall-head and with broad eaves having strongly projecting, curved brackets at corners and adjacent bay windows, and similar, smaller brackets between. Hipped roof is clad in modern, profiled sheet-metal, with traditional ogee gutters and corrugated down-pipes.

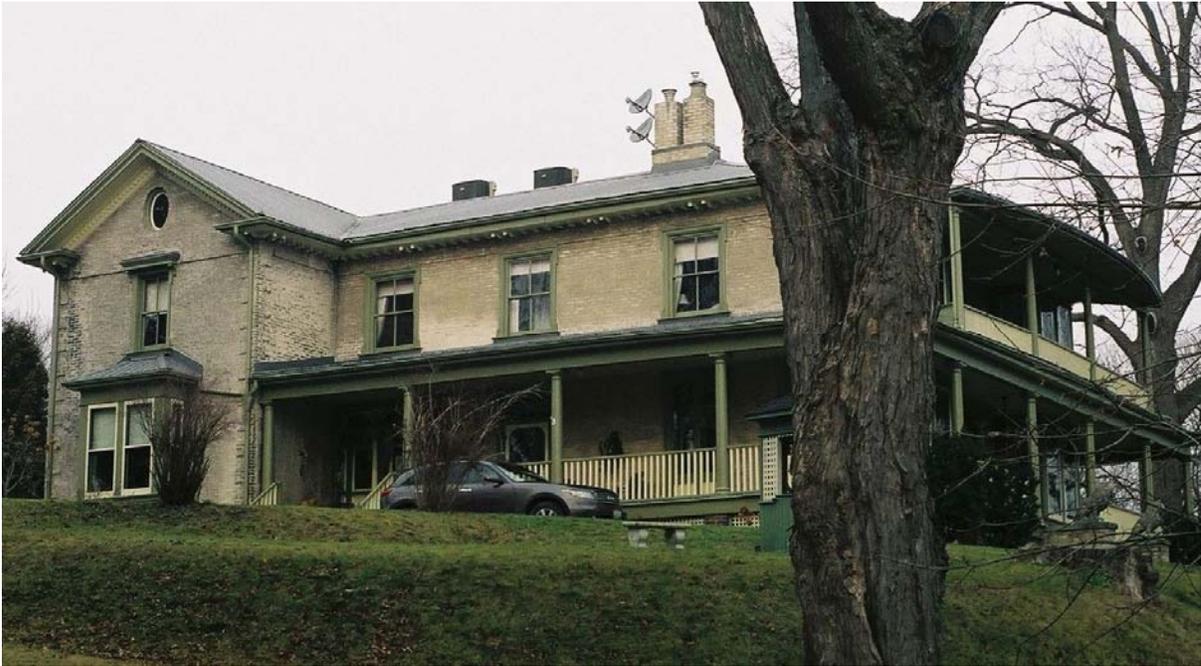
- South Elevation comprises eastern wing (see above) and projecting, gabled wing at LH side. Hipped-roof verandah is as described (but without upper level) and ends at broad wooden stairway to unusual entry (assumed a later alteration, and now apparently main entry) next to projecting gabled wing. Doorway consists of two fixed, door-like panels flanking central, half-glazed door. Door and fixed, half-glazed side panels with applied swags at bottom panels are separated by tapered, fluted columns with traditional bases and capitals. Masonry recess to doorway is lined with triple wooden panels at sides, corresponding to panel and pane heights in door. Transom windows are unusual: segmental-arched window at center, while outer window-heads curve down towards column at central bay and are rectangular at outer corners. Further to right, single door (with Colonial-type screen door) has rectangular transom window, while doorway further to east has pair of full-height French doors. Wooden architraves at latter two openings, and at three, 2/2 second-floor windows, are eared at top and bottom. Masonry throughout is buff-brick with projecting quoins. Gabled Wing, also with projecting quoins, has squared rubble foundation plainly visible. Ground floor has recent, square-plan, bay window with pair of 1/1 front windows having three simple fluted pilasters, set over continuous moulded sill and two plain, recessed panels. Sides have narrow, 1/1 units over similar sills and panels, with entire structure built off visible joists. Hipped-roof is finished in ribbed sheet-metal. At second floor, central 2/2 window again has eared wooden architraves, and small entablature on modest wooden brackets. As elsewhere, brickwork corbels out slightly at upper second floor. Gable has central, vertical oval window framed by header bricks. Gable trim differs sharply from trim elsewhere, and consists of bold dentilled band between upper and lower mouldings, adjacent plain soffits and fascias. Eaves have full returns at gables, and rainwater goods and roofing are as described. A plain (rebuilt), double chimney exists at west pitch.

- West Elevation – Symmetrical elevation at Pine Street South has elements as described, and consists of three-bay front with 2/2 windows throughout, and (recent or rebuilt) hipped-roof entrance porch. Paired larger, and smaller, eaves brackets are grouped unrelated to elevation.

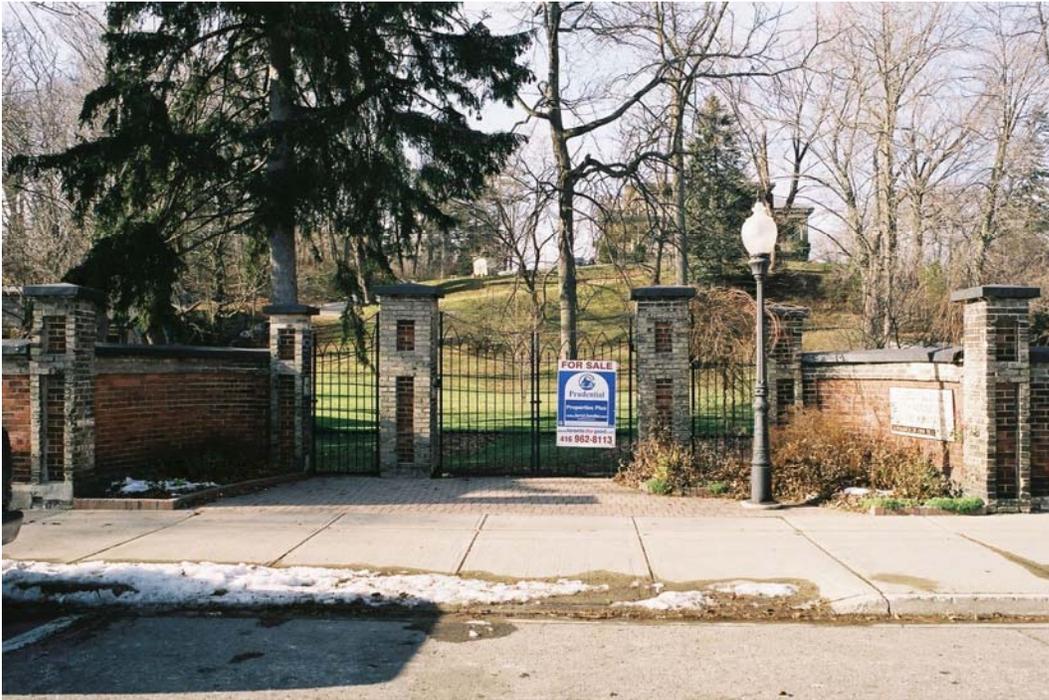
- Walls and Gates – John Street Walls are built in hand-made, red and buff brick not in keeping with house itself. Wall is built of red brick, with triple course of buff-brick at top and bottom, as well as apparently bevelled, upper buff-brick course at base, most of which is now cement rendered. Hipped coping is, surprisingly, made of wood, now covered with painted sheet-metal, all of which appears original. Wall is divided into bays by projecting piers, with bases and tops as described, and with corners also in buff-brick, framing recessed red-brick panels. Towards north end, concave curve recesses wall back into property, with taller piers having also upper, recessed red-brick panels, marking pedestrian and coach entries, the latter having somewhat wider piers. Fine, gothic iron gates are attractive, but assumed not to be original. Line of old drive beyond is visible, winding its way up to house, and is important component of garden landscape. South Pine Street Gates, and balustraded walls beyond, are more recent and are made of concrete cast into neo-Gothic forms, with bevelled corners, recessed panels and concentric discs, and with complex pyramidal copings with mini-dormers at each face.

- Comments – The house is something of an anomaly, being quite different in style and materials from the walls along John Street, and also unusual within itself. Possibly original building is pitched-roof wing at west side, dating from circa 1850, later altered and extended by Victorian addition to east, and altered again more recently in various areas. Without detailed investigation, evolution of building is hard to discern. House is generally in very good repair, though lack of lintels is causing settlement at west elevation. The John Street Walls are a most unusual and valuable element within the street, and are in need of considerable repair. Failed, or failing, sheet-metal flashings, as well as general weathering and movement, are causing decay in masonry, particularly at upper levels; and low-level render should be removed and bricks be replaced. Extensive reinforcing rods and bars indicate other problems which need to be addressed. Masonry at concave entrance gates and piers is generally in better repair. At the Pine Street South Gates, the piers surface render has many small cracks and will require repair soon. Driveway up from John Street is another valuable component of the historic context of this house, and indeed of John Street. See also the Guidelines for any proposed repair or alterations to aspects of this extensive, diverse and most interesting property.
