5.2 Queen Street, west side

10 and 12 Queen Street

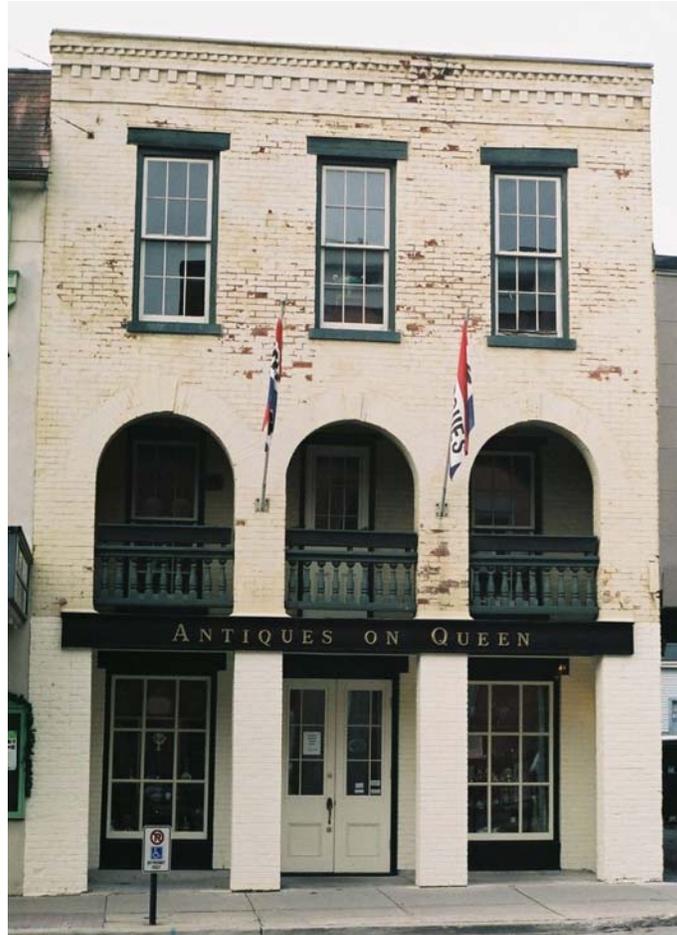
- Three-storey, painted-brick building with recessed façade at lower two floors (c.1860), and extensive addition at rear, of varying ages. Known in the nineteenth century as the British Hotel, building is **Designated** under the Ontario Heritage Act, Part IV.

- Description – Three-storey, three-bay brick building is much altered at lower two storeys, with recessed elements apparently changed long after original construction. Ground floor comprises three bays, with central piers built of (painted) metric-brick piers rising directly from grade. At front wall, within recessed bays, similar piers (note weepers) frame nine-pane shopfront windows with low wood panels below and plain wood lintels. Central bay has pair of wood doors with asymmetrical, six-pane windows in each and single large panel below. Signage consists of almost full-width wooden sign framed by simple moulding, and with raised, gilded letters. Sign is perhaps strategically placed to hide structural face of gallery floor above. Second floor has similar plain piers rising to round arches with projecting brick keystones, and again with recessed, inner front wall. Arches have deep brick voussoirs and appear, as at ground floor piers, to be later alterations. Gallery enclosure is low, profiled handrail with sturdy turned balusters, typical of circa 1900 work, suggesting possible date for upper alterations to façade. Windows within are tall, 6/6 units at either side, and recent, 9-pane vinyl door, with single lower panel, at central bay. Lintels throughout are again plain wooden beams. At third floor, painted brick masonry continues to frame three apparently old, 6/6 windows with masonry sills and plain wooden lintels. At wall-head and parapet, masonry corbels out four courses above lintels, and upper levels comprise double course of corbelled, stacked headers, two plain courses in common bond, then single, dog-toothed course and two additional courses in common bond to crown façade. Parapet is flashed with simple drip-cap flashing in painted galvanized metal.

- **Comments** – At **front elevation**, building is unique within Port Hope, with its recessed front wall and two-storey round arches. Unusual doors to shop should be replaced with more suitable period doors. At second floor, central voussoirs are failing and require attention. And at third floor, extensive spalling paint and bricks indicate water (whether rain or vapour problem), which should be investigated and remedied. At **side elevation**, diversity of building provides attractive back-lane presence, though revealing of windows – if these exist – would be an improvement, and these could be blacked-up with painted glass if necessary. At **rear elevation**, blank brick wall is not unattractive, and though metal-clad and rusty crenellations are odd they are in keeping with a theatrical building. This elevation, facing the parking lot and lane beyond, is sufficiently prominent that there might be something more for the public view – perhaps suitable advertising for events being staged at the theatre.

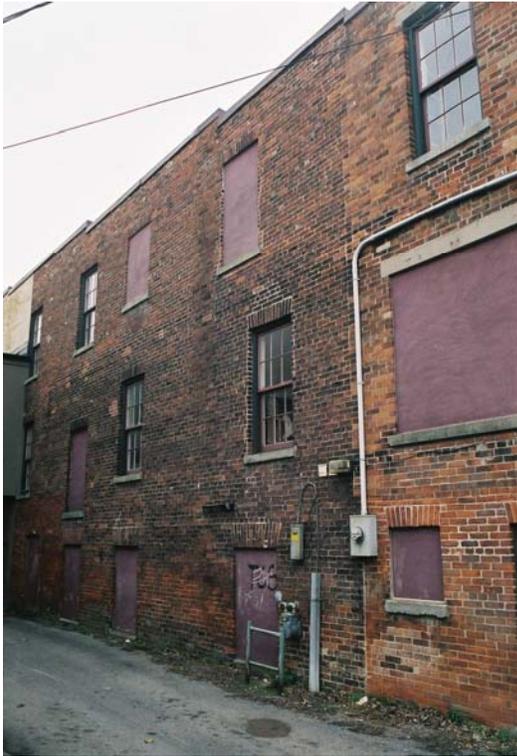
- **Side Elevation** – North elevation of this building is a wonderful lane structure, an imposing three stories of various periods of old, red-brick masonry, with headers every sixth course, and a number of tall apertures, some with 6/6 windows in surprisingly good repair, and some boarded over. A single door, with segmental-arch head, is boarded up just beyond covered passageway. Elsewhere at ground floor, window-heads are flat arches, built with multiple-brick voussoirs extending to uniform course line. At two upper levels, voussoirs are simple, soldier-course bricks only, again in flat-arch form. Sills are concrete throughout and parapet is capped with pre-painted metal flashing. **More recent addition**, buttressed at regular intervals and without windows, extends building deep into lane, and is part of Capitol Theatre, and so circa 1930, whereas volumes to east appear to date from late 19th century.

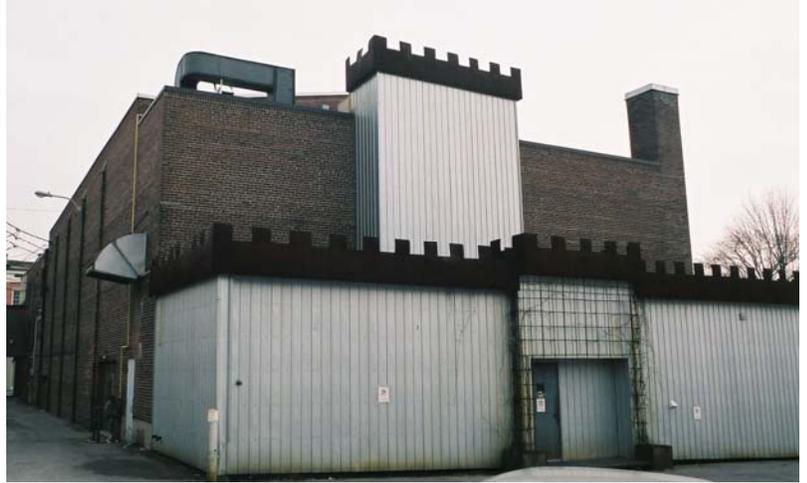
- **Rear Elevation** – West elevation, plainly visible from Lent Lane, is rear of Capitol Theatre, and is also built of red brick as at north side but is windowless, in keeping with theatre use. Plain, one-storey addition to rear is clad in vertical metal siding and topped with a exotic crenellations in rusted iron. Similar, set-back addition rises full-height at centre of building, also with crenellations. Beyond a horizontal, metal-flashed parapet to rear wall is another, similarly capped, gable wall.
