5.6 John Street, west side

54 John Street

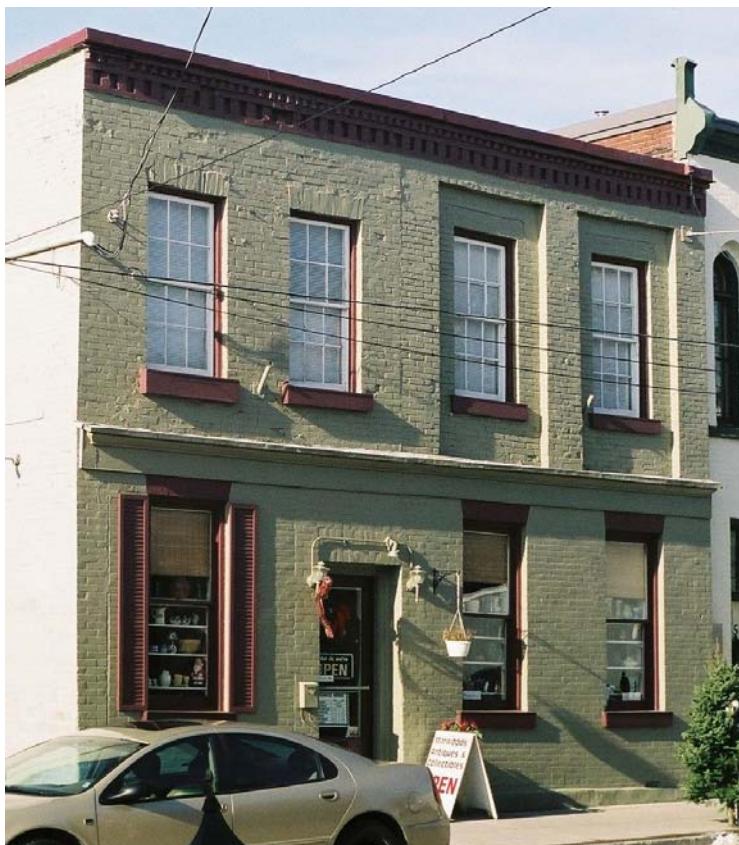
- Two-storey, flat-roof (painted) red-brick building with varied upper-floor masonry (c.1870)
- Description – Variations and toothed- and butt-joints in brickwork indicate composite nature of what appears at first to be a single building. At ground floor, building comprises four bays, with entry at second bay from left. Painted brick masonry is built off cement-rendered base at LH side, which may indicate stone foundation behind. Low door, without transom window, appears to be one of several changes to building. (Toothing-in of brickwork and discrepancies in course heights to left of door indicate alterations in this area.) Door itself is fully glazed, modern wood door reached by single concrete step, with soldier-and-header course voussoirs forming flat arch above. Ground-floor windows are three tall, 1/1 units with boxed-in wooden sills and flat arches apparently consisting of single soldier-course only. Modest fascia, spanning full-width of building just above window-heads, has beaded lower edge and chunky cornice, which returns into fascia at ends of building. At second floor, differing aspects of building are more apparent. Upper four bays comprise, at RH side, two recessed brick panels between plain brick pilasters, then central butt-joint where course heights change, and flush brickwork in two LH bays. Windows are 6/6 throughout, all with boxed-in wooden sills, RH windows being higher and having wooden lintels. Units at LH side have flat-arch, soldier voussoirs as at ground floor. At parapet, masonry consists of corbelled course under double course of alternating projecting and recessed headers, then additional plain course below slightly projecting dog-toothed course, with additional top courses largely hidden by deep metal flashing.

- South elevation, over rendered base, is built in painted, common-bond brick with headers every eighth course. Narrow, bricked-up aperture towards LH side is without extant sill or lintel/arch.

- Rear elevation retains original 6/6 windows at upper level, much hidden by large wooden deck.
- Comments – Simple and traditional brick building is more complicated in origin than it seems, yet most attractive in its old variety. Bricks below parapet are damaged, presumably where water has entered masonry from behind. Paint also probably hides a variety of brick types, and this should be investigated before removal is considered as masonry may comprise a wide variety of bricks and mortar types. Chimney (not visible from front) needs repair, and various replacement bricks.
