61 BRAMLEY STREET NORTH

GEORGE MANNING FURBY HOUSE circa 1861 (modifications circa 1870)

Date Designated: April 21, 1986 to By-Law No. 28/86, SCHEDULE B-6

ARCHITECTURAL DESCRIPTION

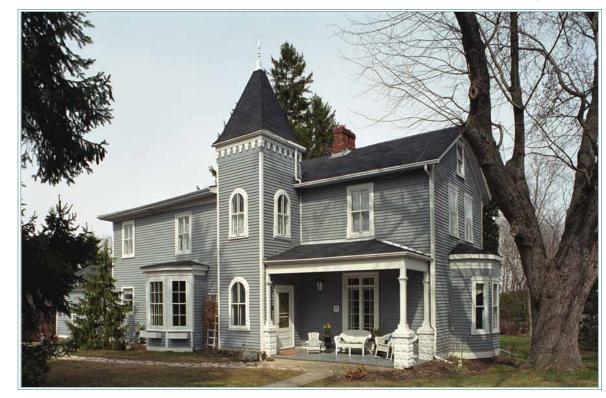
This clapboarded frame building of two storeys is a composite of irregular form mid-Victorian early and incorporating structures as well as a number of later alterations. Its significance is principally its composite character as a building in evolution with exterior and interior details representative of several decades of the nineteenth century. The tower was a late manifestation of the Italianate.

The main front facing Bramley Street is an informal composition accentuated by a two and a half storey tower with steeply pitched hip roof and centre pinnacle and upper windows having eared trim and slightly

pointed heads. This tower, entered from the porch to the side, forms a vestibule covering the front entrance, a door case with sidelights and transom. The portion to the north or left of the tower, now two storeys with a very low-pitched roof and a single storey extension to the rear appear to be the oldest parts of the building. The west bay, to the dining room, exhibits the earliest trim seen in the house, a mid-nineteenth century version of the cyma-reverse and sloped fillet. This section has a front corner room (to the south-east) with a corner fireplace faced with a marble mantelpiece having pilasters.

Externally the tower, bay windows, front section and rear single storey wing are the principal features. The significant interior detail includes the entrance door case, three mantelpieces, the plaster cornices and rosettes in the living room and sitting room and the staircase and hall archway.

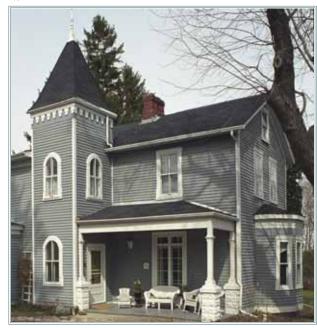
ARCHITECTURAL DETAIL

The front two-storey L-shaped section with gable roof facing Yeovil Street was a later addition. Windows have eared architraves which flare out at the sill, a typical detail of 1870's buildings.

The next alteration appears to be the front two-storey attic L-shaped section with gable roof facing Yeovil Street, having French windows in one-and-a-half plane width, originally facing the porches, that in the south-east angle now closed in. Windows have eared architraves also flared out at the sill, a typical detail of 1870's buildings. This section has a bay to the south room, the most handsome space with plaster cornice and
